WEVO RARB Console installation on pre 1972 chassis.

The photographs and descriptions in this document are intended as a guide to assist those who are intending to install the WEVO RARB Consoles on a pre 1972 chassis.

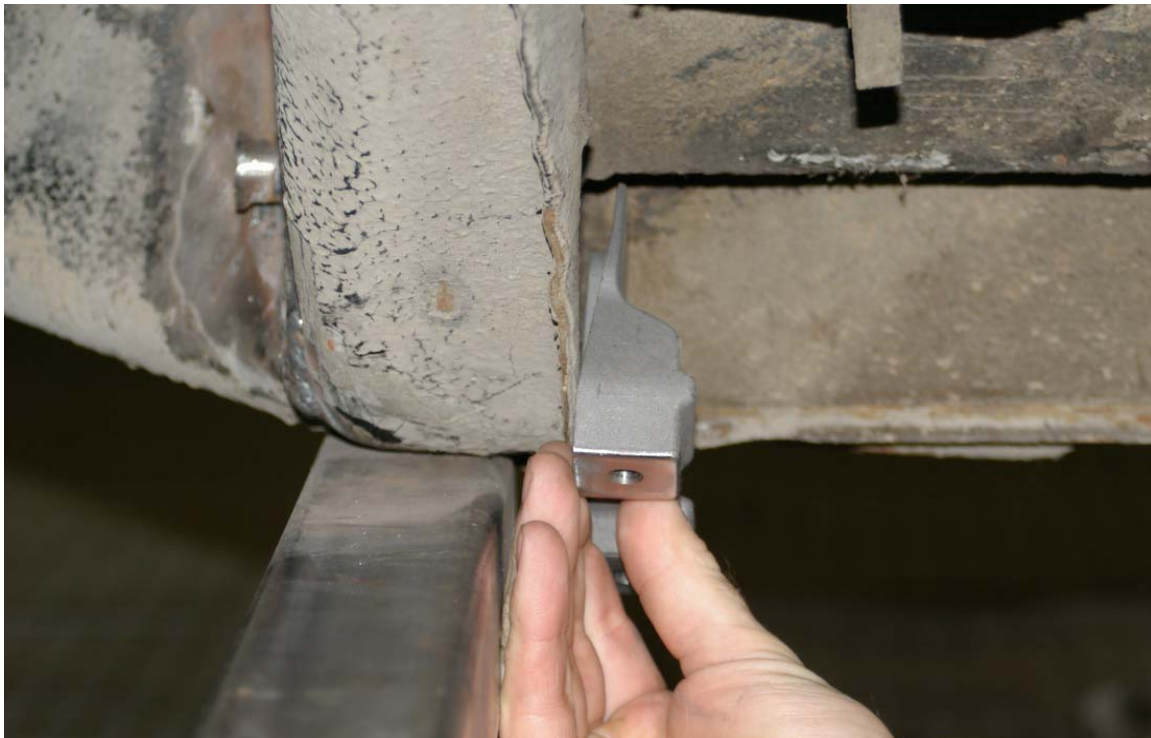
In basic terms the RARB consoles must be installed backwards – with the outer surface (as designed) facing inwards. This photo shows the RARB console being held in position by hand on a 1969 chassis. You can see the curved surface (normally outwards in a 1972 – 1986 chassis) is now facing inwards and the nominally flat face is towards the surface of the chassis box section – albeit with a gap visible.

Cut a strip of material 2 – 3 mm (.080" - .125") thick and ~ 10mm (3/8"ths) wide. Bend this to match the perimeter shape of the "tombstone" section of the RARB console.

Weld this material perpendicular to the mount so that you have a flange extending laterally to close the gap between the RARB console and the chassis box section.

Now grind the flange into the correct taper and contour to allow the RARB console to nest tightly against the chassis along the bottom edge, with the minimum of flange section.

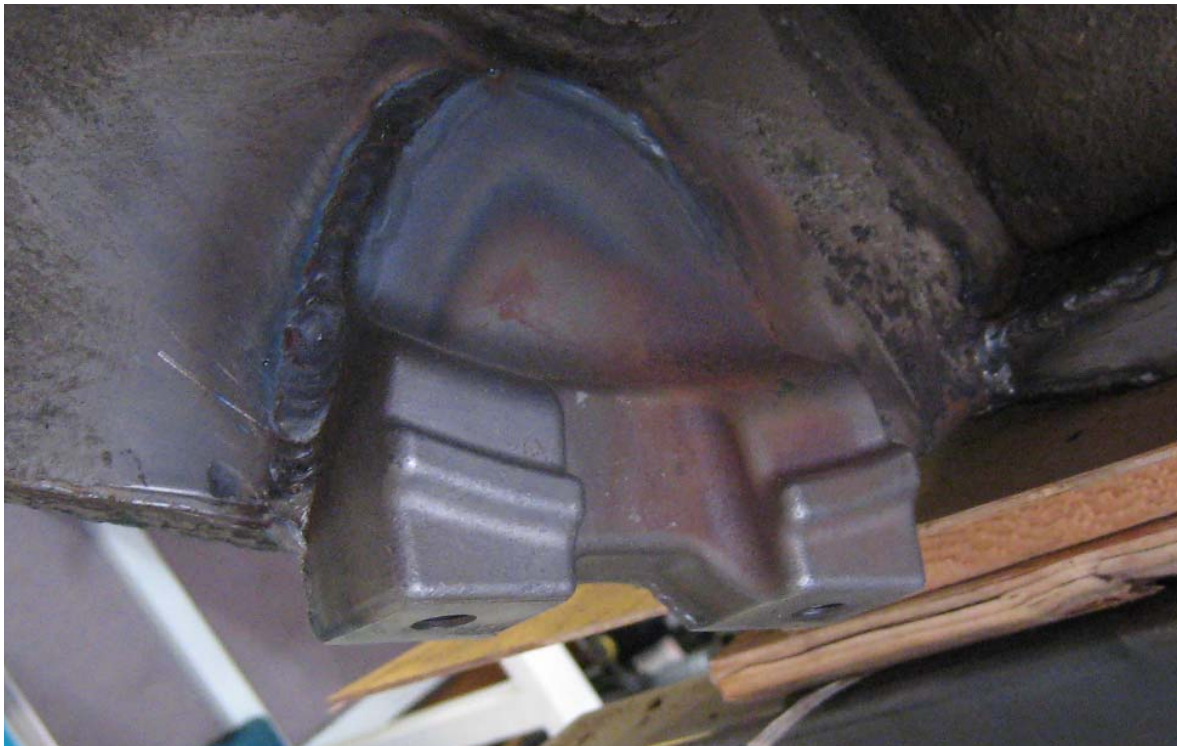
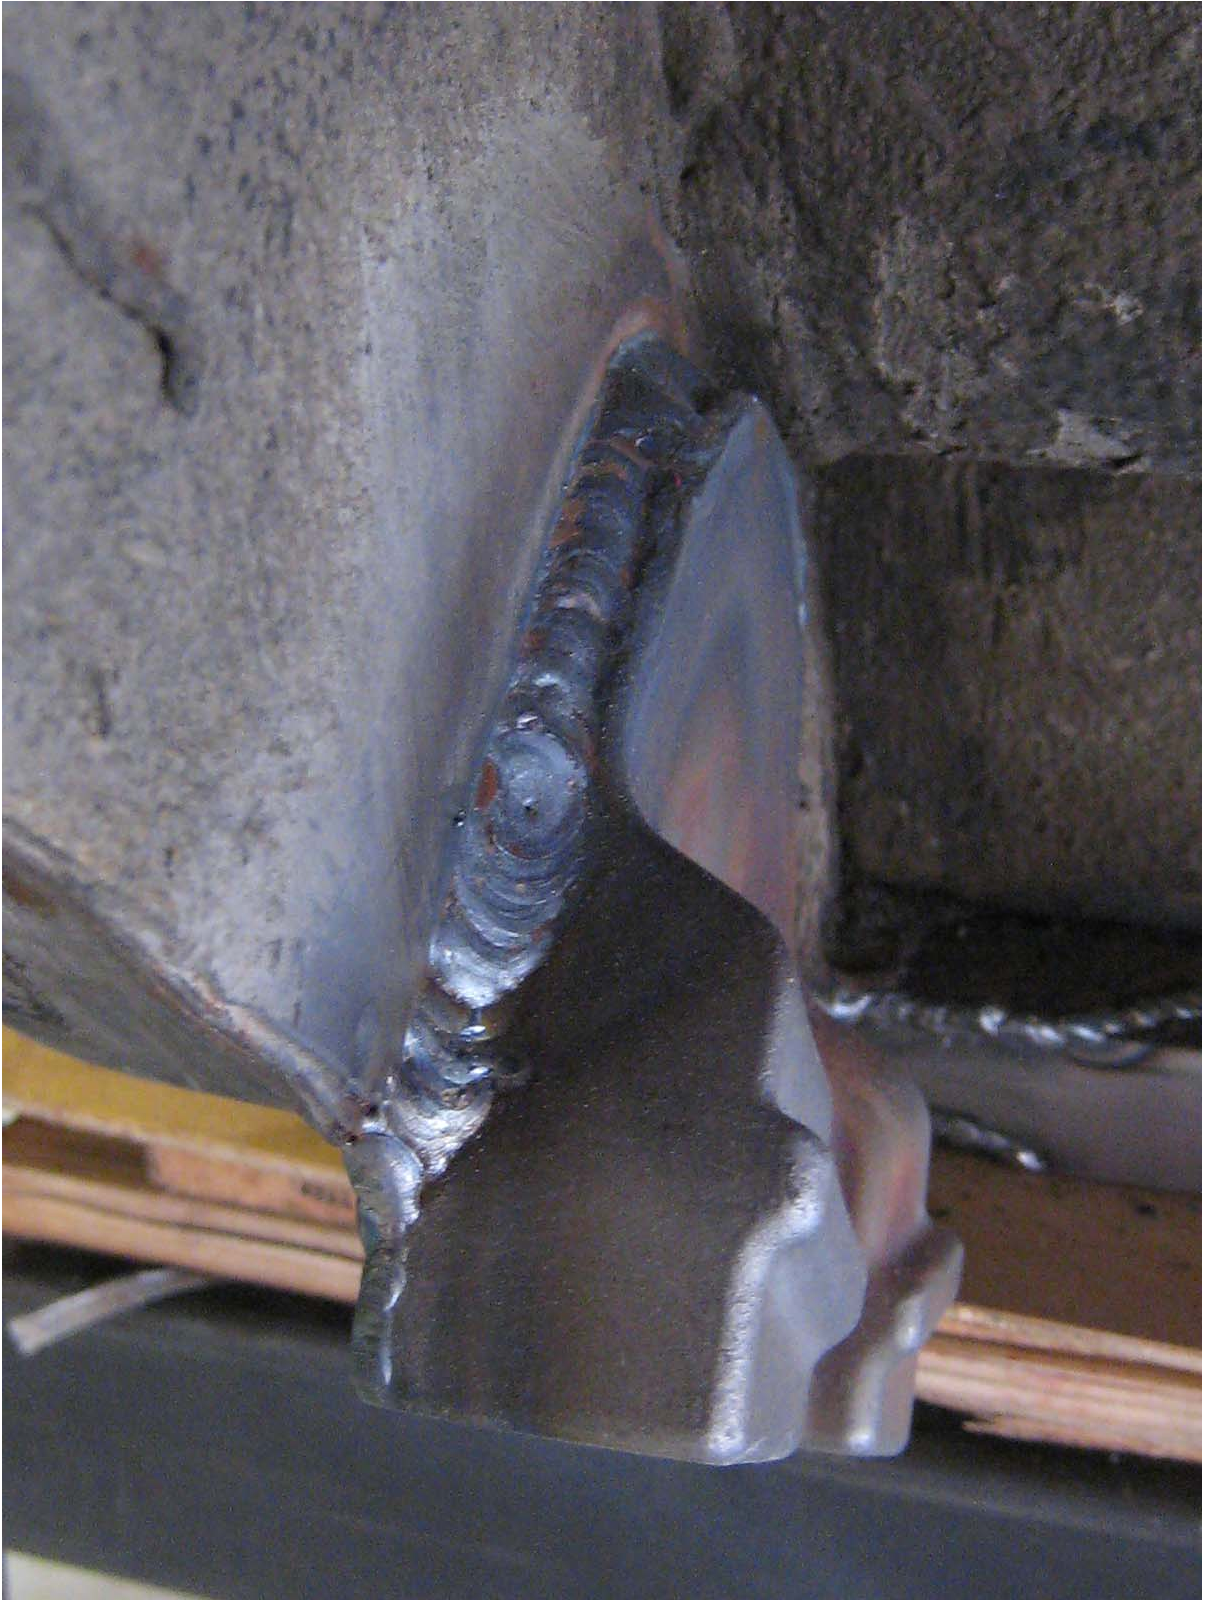
These photos show the RARB fully welded in position. You can see the prominent MIG weld between the RARB Console and the chassis box section.

You can also see where the mounting flange as described above is welded, you can see some evidence of the TIG weld that was used to add the flange to the RARB console before that flange was shaped and the RARB console was welded to the chassis.
